Investigating Parameters of Lekatech's Electric Hammer

Title Investigating Parameters of Lekatech's Electric Hammer

The parameters of Lekatech's new electric hammer prototype were explored. Initially, 5 different settings on the machine were controlled to explore its whole frequency range. They were tested with 3 different tool types and 2 types of concrete. The vibrations on the machine's tool and housing were measured, as well as the piston's (mover's) position during hammering. The fashion in which the concrete broke was also looked at. The results showed that the blunt tool took the longest to break the rock but also generated the most cracking, and the time taken for the concrete to break increased with frequency. Other conclusions were also drawn from the results.

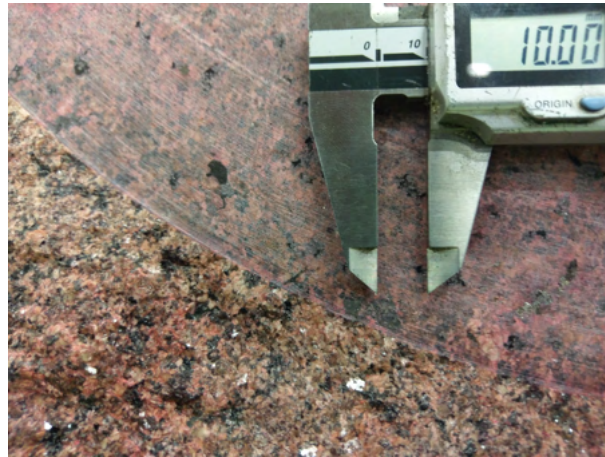
Figure 41: The granite used for the experiment; shown are a sawed and a broken section, although this piece is just a demonstration to show the grain size better, and the actual test blocks had no smooth sawed of section prior to testing.

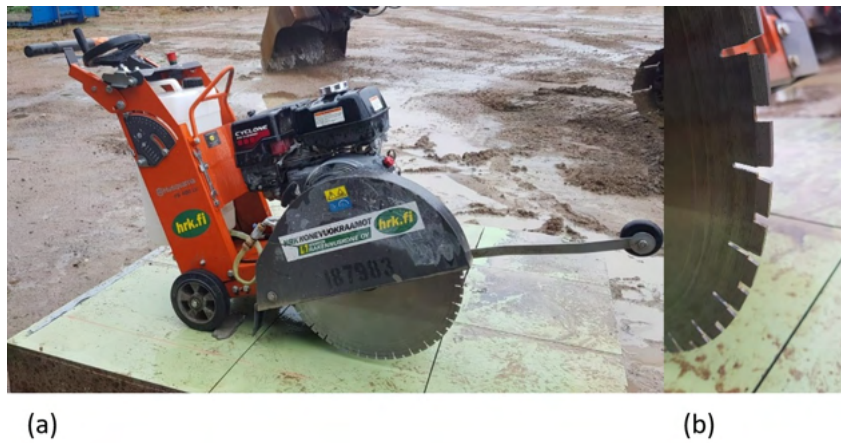
Figure 43: Pictures showing (a) the diamond saw used and (b) a close-up of its diamond-tipped blade.

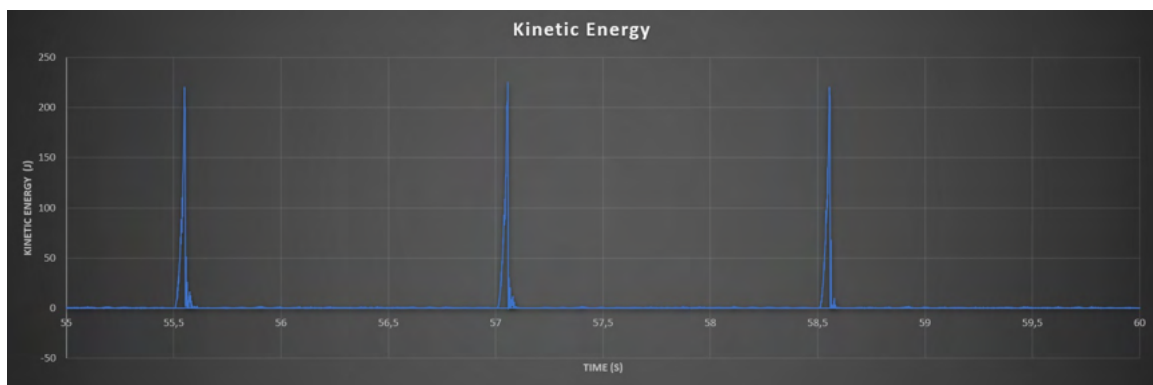
Figure 44: Kinetic energy calculated from the displacement graph of the laser on top of the mover.

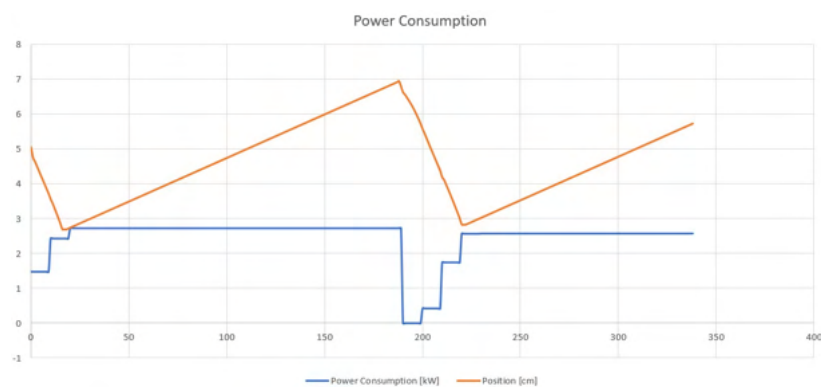
Figure 47: Power Consumption and displacement graph for 5 Hz.

Figure 47 below shows the power consumption of the inverter in the same graph as the position of the mover for 5 Hz.

The power consumption graphs shown above clearly show that the power consumption of the inverter is constant when the mover's position goes up, and decreases quickly to zero as the mover is accelerated rapidly downwards onto the tool.

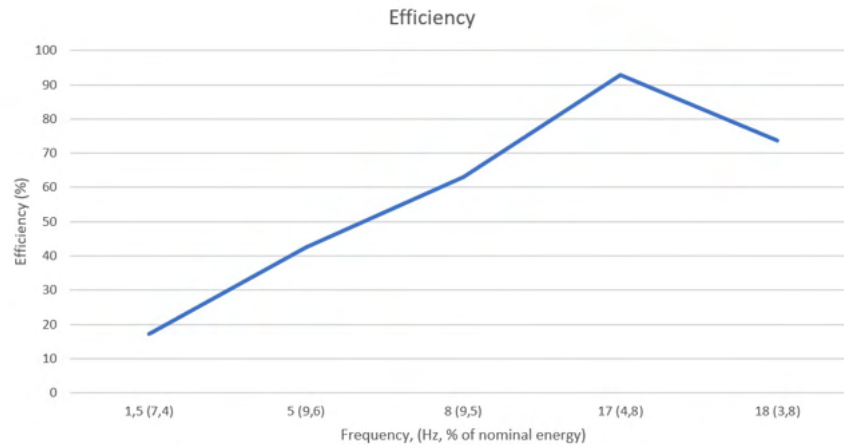
As can be seen in Figure 54 below, the energy efficiency varied significantly with frequency at the relatively low energy levels tested. The clearly recognisable trend is that the efficiency is lower for the low frequencies and higher for the high frequencies. It will be interesting in the second testing iteration to see the behaviour of the machine's energy efficiency with higher impact energies.

Figure 54: The efficiency with each of the 5 different frequency settings tested.

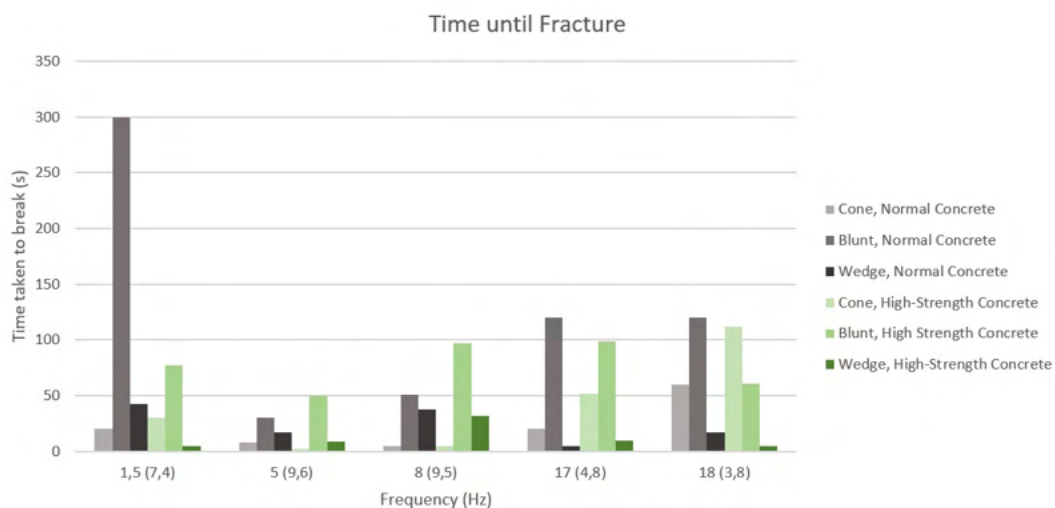
Figure 55: Time taken from the start of hammering until fracturing occurred.

Figure 55 above shows that the blunt tool consistently takes the longest time to break the sample. There is no significant difference between the wedge and cone tool types.

Figure 55 below shows the difference between the different samples and the time it took for them to break.

There is no significant difference between the time taken until fracture between the two types of concrete.

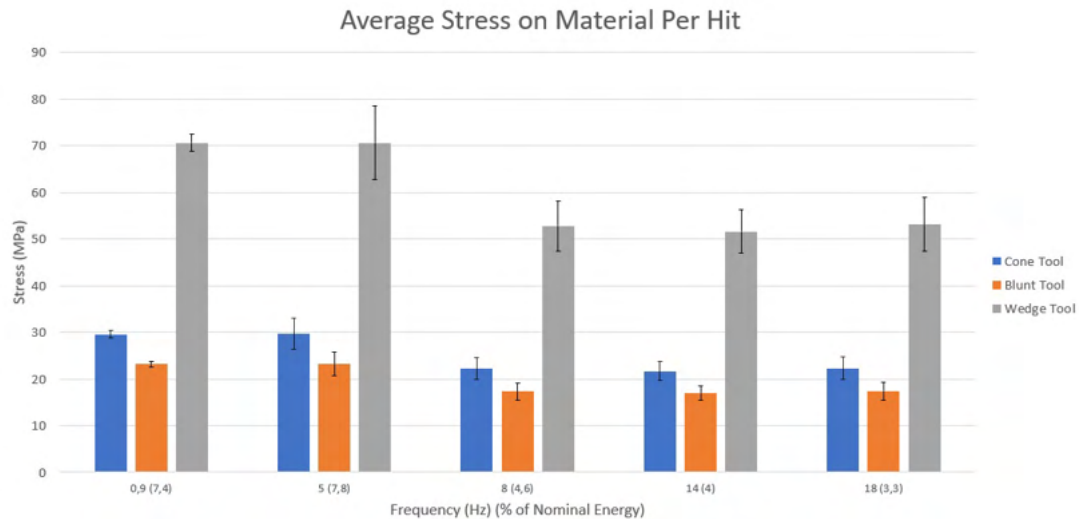
Figure 56 below shows how the stress varies with stress and tool type. The value was the average of all the peaks in the acceleration graphs for each frequency, which were obtained by differentiating the laser displacement graph twice. The error bars were a half population standard deviation above and below the mean, after any outliers had been removed.

Figure 56: Stress calculated using the same force for each frequency with varying cross sectional areas.

Figure 56 above shows that the wedge tool clearly exerts more stress on the material than the other two tools. There is no significant difference between the other two tool types in terms of stress.

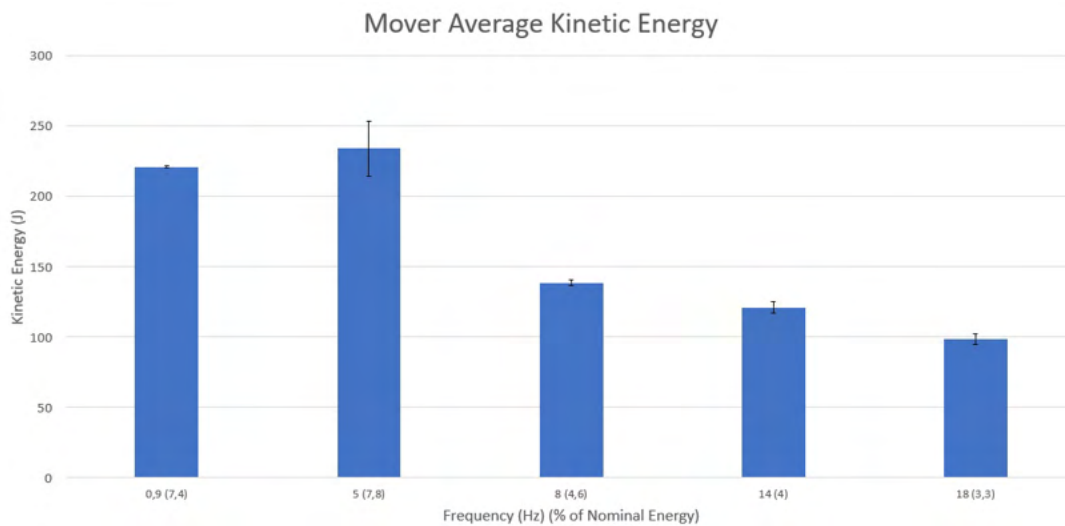
Figure 58 below shows the variations in the maximum Kinetic Energy of the mover with varying frequencies. Only the variations in the graph will be discussed here, the energy efficiency is discussed in the ‘‘Energy Efficiency’’ section.

Figure 58: Average Kinetic Energy of the mover recorded at each frequency.

Figure 58 above shows that the kinetic energy of the mover is highest at the settings for the 0.9 and 5 Hz frequencies. For the 8, 14, and 18 Hz frequencies it is significantly lower than for 0.9 and 5 Hz frequencies, although variation between the former three is statistically insignificant.

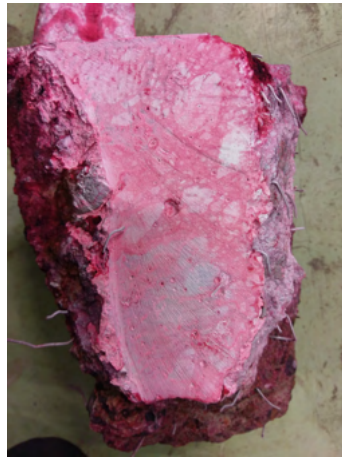
Sample Results: Figure 62 shows the resulting sample after it had broken.

Figure 62: The area around the impact zone.

- There was cracking at the bottom of the block but little around the impact zone.
- The sample took approximately 20 seconds to break when hitting relatively close to the edge.

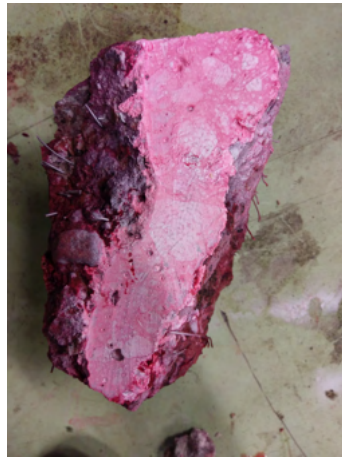
Sample Results: Figure 66 shows the resulting sample after it had broken.

Figure 66: The area around the impact zone.

- There was cracking at the bottom of the block but little around the impact zone.
- The sample took approximately 8 seconds to break when hitting close to the edge

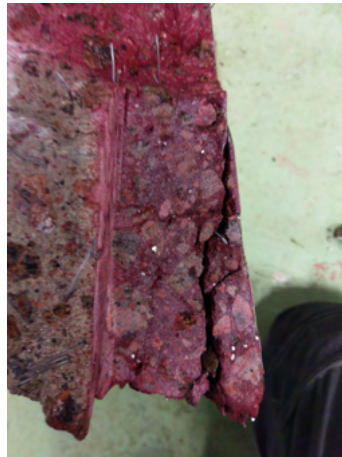
Sample Results: Figure 70 shows the resulting sample after it had broken.

Figure 70: The area around the impact zone.

- There was cracking at the bottom of the block and at the side and some close to the impact zone parallel to the top surface.
- The sample took about 5 seconds to break when hitting near the side.

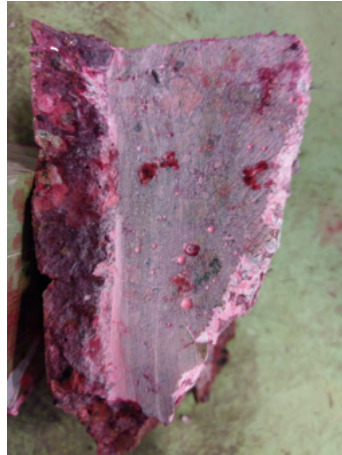
Sample Results: Figure 78 shows the resulting sample after it had broken.

Figure 78: The area around the impact zone.

- There was cracking at the bottom of the block but little around the impact zone.
- The sample did not break within 45 seconds of hitting while hitting in the middle.
- The sample took about 60 seconds to break when hitting near the side at the same spot.

Therefore, it can be said that with the cone tool on the normal, steel fibre reinforced concrete, the cracking is more prominent at the bottom and sides than at the top around the impact zone.

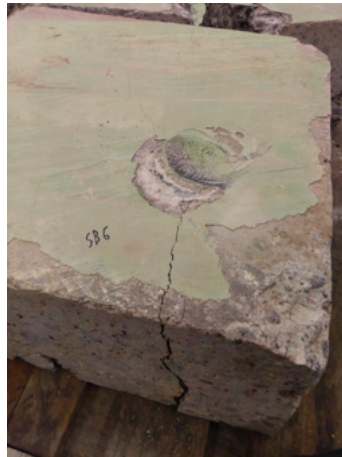
Sample Results: Figure 83 shows the resulting sample after it had broken.

Figure 83: The area around the impact zone.

- There was cracking around the impact but only one large crack from each side to the nearest free surface. The cracks were larger at the bottom than at the top.
- The cracking took extremely long to start, with 300 seconds of hitting required to have cracking and even then fracturing not occurring when hitting close to the side of the block.

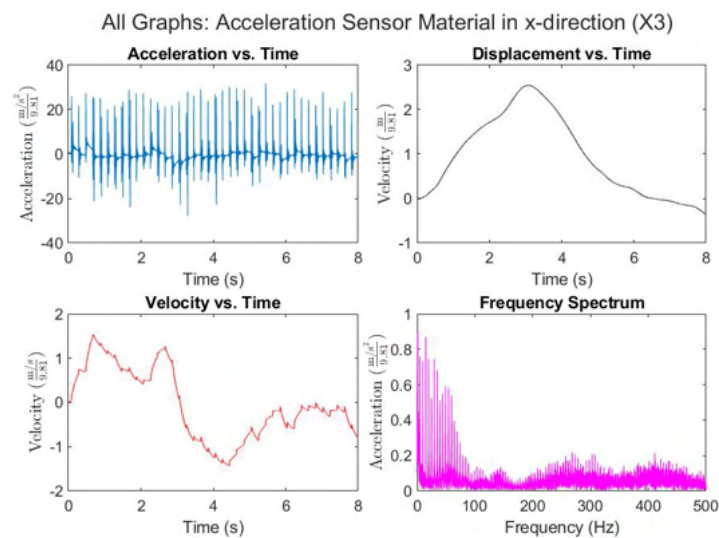
Acceleration Sensor Material in x-direction: Figure 86 below shows material vibrations in the x-direction.

Figure 86: Results of acceleration sensor on material.

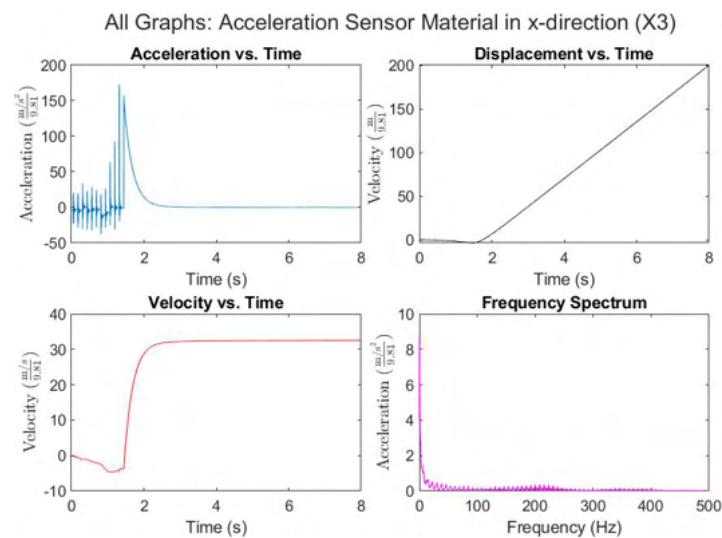
Acceleration Sensor Material in x-direction: Figure 96 below shows material vibrations in the x-direction.

Figure 96: Results of acceleration sensor on material.

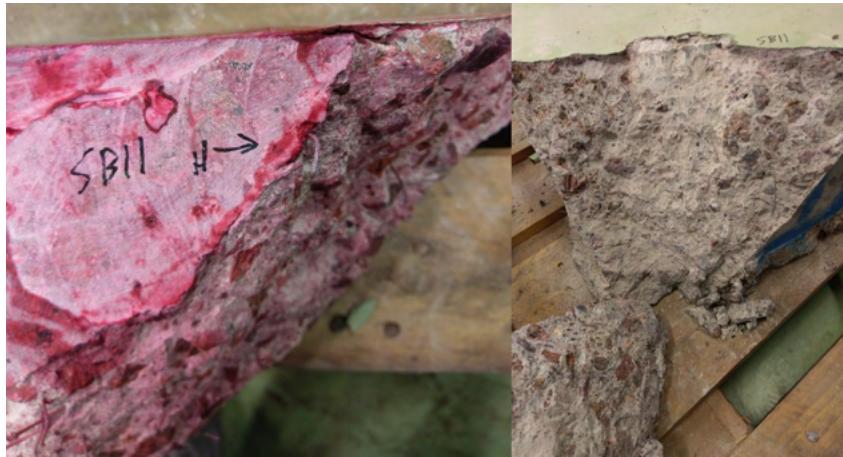
Sample Results: Figure 104 shows the resulting sample after it had broken.

Figure 104: The area around the impact zone.

- There was some slight cracking at the impact zone, apart from that there was little fragmentation and the big piece broke off cleanly from the small piece. The only fragmentation occurred at the bottom of the block.
- The sample took about 43 seconds to break when hitting near the side of the block.

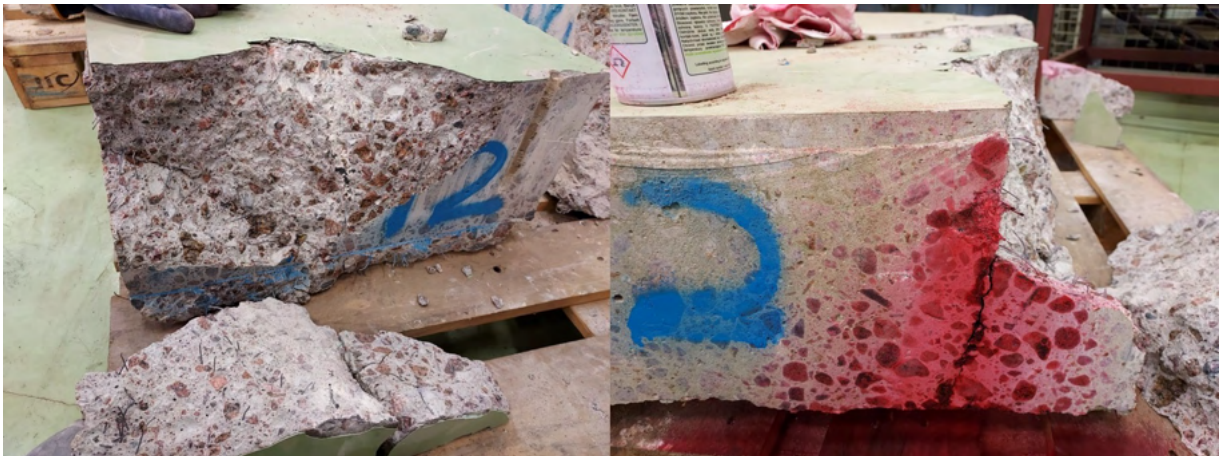
Sample Results: Figure 109 shows the resulting sample after it had broken.

Figure 109: The area around the impact zone.

- There was little cracking at the impact zone and the piece broke off relatively cleanly, fragmenting into several pieces near the bottom.
- The sample took about 17 seconds to break when hitting from the side.

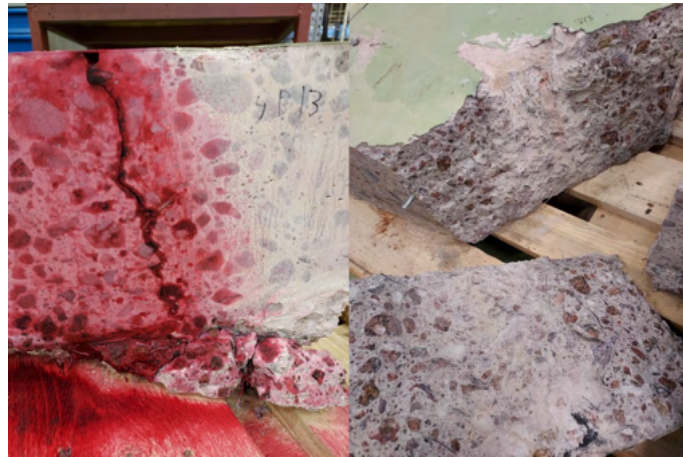
Sample Results: Figure 114 shows the resulting sample after it had broken.

Figure 114: The area around the impact zone.

- There was little cracking around the impact zone but some small fragmentation at the bottom of the block. Apart from that, there was a crack that propagated perpendicular to the wedge to the free surface (left in Figure 114).
- The sample took about 38 seconds to break when hitting was done near the middle of the block.

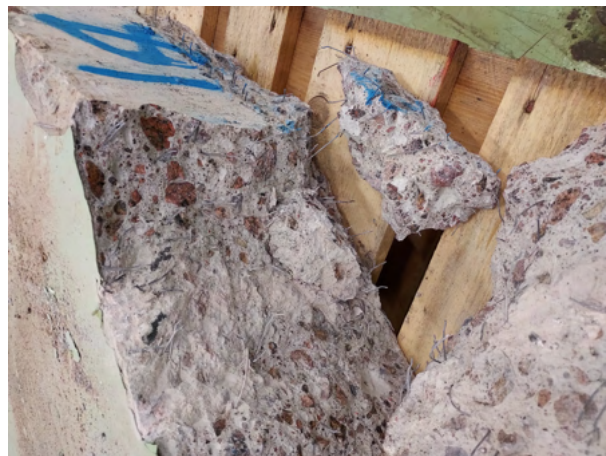
Sample Results: Figure 115 shows the resulting sample after it had broken.

Figure 115: The area around the impact zone.

- There was a little cracking around the impact zone and the block fragmented into several pieces, one main chunk that broke off and a couple of smaller pieces near the bottom.
- The sample took about 5 seconds to break when hammering was done near the side of the block.

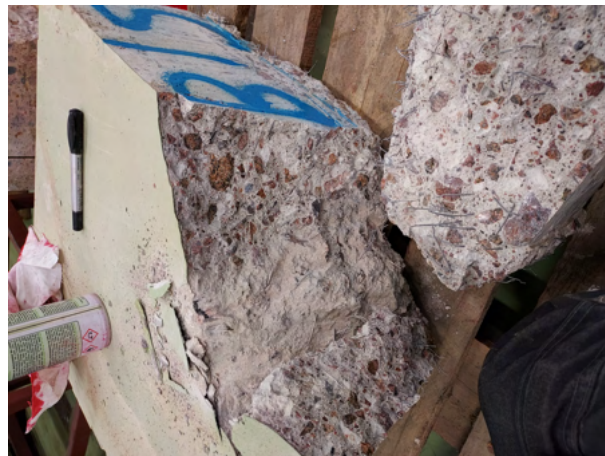
Sample Results: Figure 120 shows the resulting sample after it had broken.

Figure 120: The area around the impact zone.

For WN18, the following things are noticeable about the sample:

- There was a little cracking around the impact zone and the block fragmented into 3 pieces, one of which did not completely break off from the block.
- The sample took about 17 seconds to break when hammering was done near the side of the block

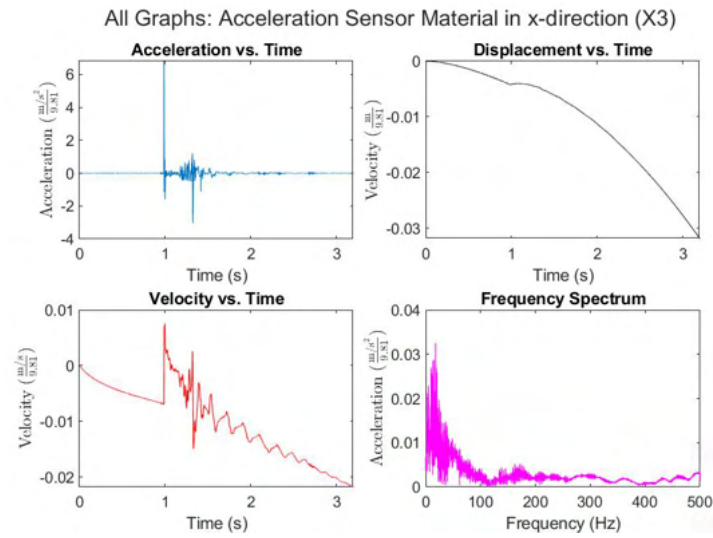
Acceleration Sensor Material in x-direction: Figure 123 below shows material vibrations in the x-direction.

Figure 123: Results of acceleration sensor on material.

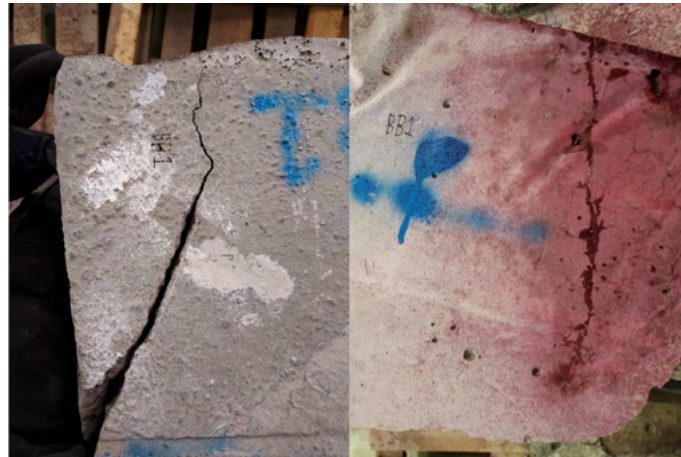
Sample Results: Figure 125 shows the resulting sample after it had broken.

Figure 125: The area around the impact zone.

- Only one piece broke off very cleanly, although this piece did have a crack perpendicular to the wedge of the tool to the free surface, where some other, fine cracks branched off from it (left image in Figure 125).
- The sample took about 5 seconds to break when hammering was done near the edge of the block.

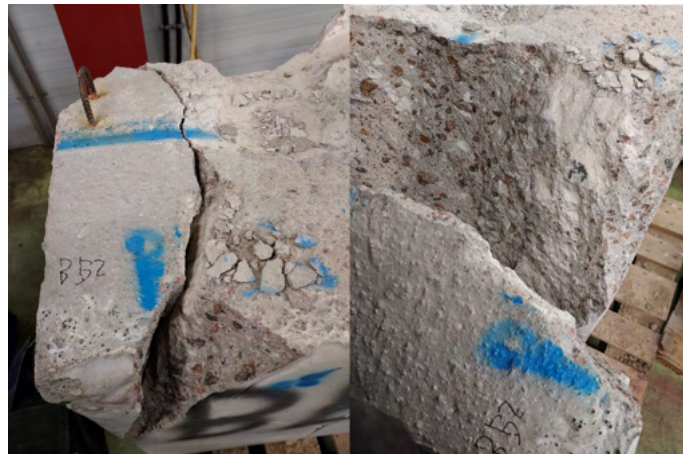
Sample Results: Figure 130 shows the resulting sample after it had broken.

Figure 130: The area around the impact zone.

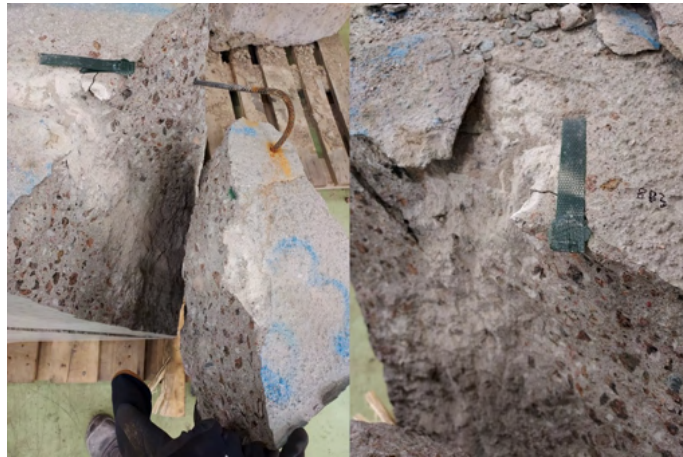
Sample Results: Figure 135 shows the resulting sample after it had broken.

Figure 135: The area around the impact zone.

- There was some visible cracking around the impact zone, with some fragmentation, although the main block broke off cleanly.
- The block took around 32 seconds to break off when hitting near the edge.

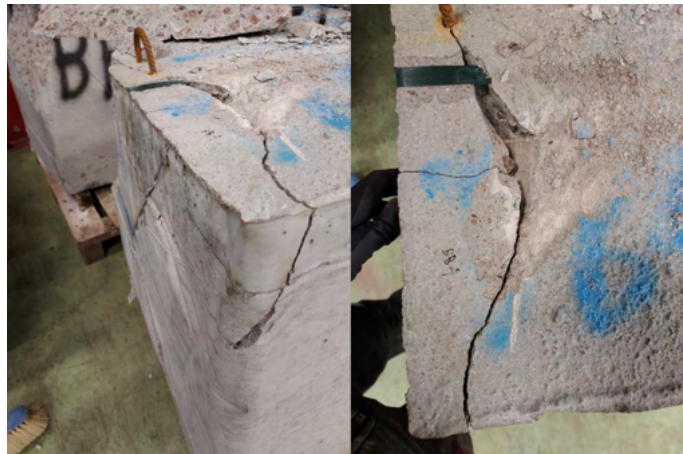
Sample Results: Figure 140 shows the resulting sample after it had broken.

Figure 140: The area around the impact zone.

- There was some slight fragmentation around the impact zone, otherwise the block broke off cleanly in two pieces, with one crack again perpendicular to the wedge of the tool.
- The block took around 10 seconds to break off when hitting near the edge.

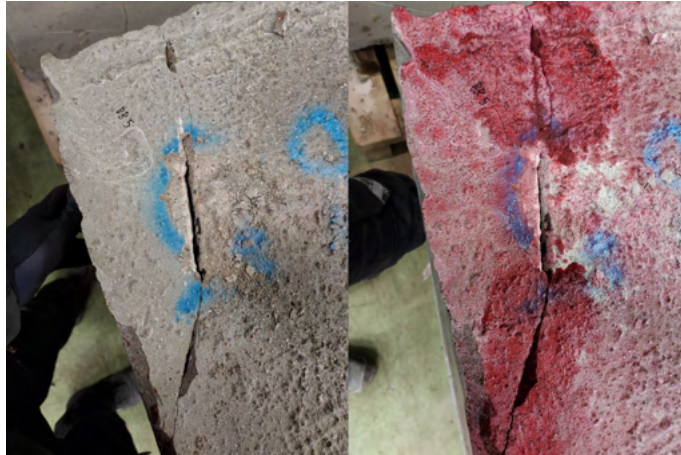
Sample Results: Figure 145 shows the resulting sample after it had broken.

Figure 145: The area around the impact zone.

- There was some slight fragmentation and minor cracking around the impact zone, otherwise the block broke off cleanly in one piece.
- The block took around 5 seconds to break off when hitting near the edge.

Therefore, it can be said that with the wedge tool on the high strength concrete, the cracking is very clean, with sometimes a little fragmentation visible around the impact zone. It is also noticeable that sometimes, a crack develops perpendicular to the wedge of the tool.

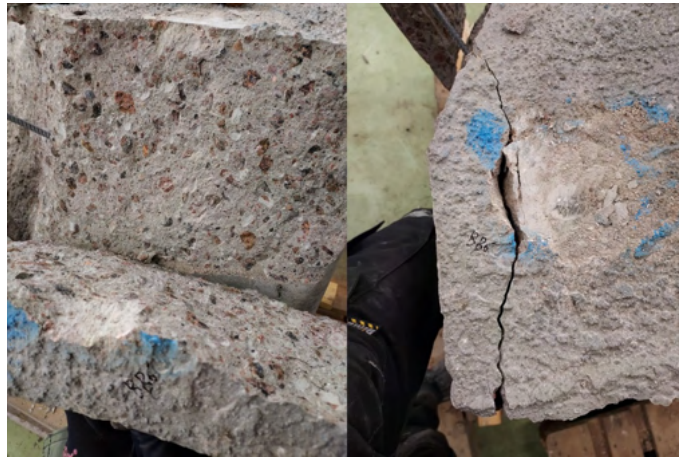
Sample Results: Figure 150 shows the resulting sample after it had broken.

Figure 150: The area around the impact zone.

- There was some fragmentation and minor cracking around the impact zone, otherwise the block broke off relatively cleanly in one piece. The crack propagation started from the side of the tool.
- The block took around 77 seconds to break when hitting near the edge.

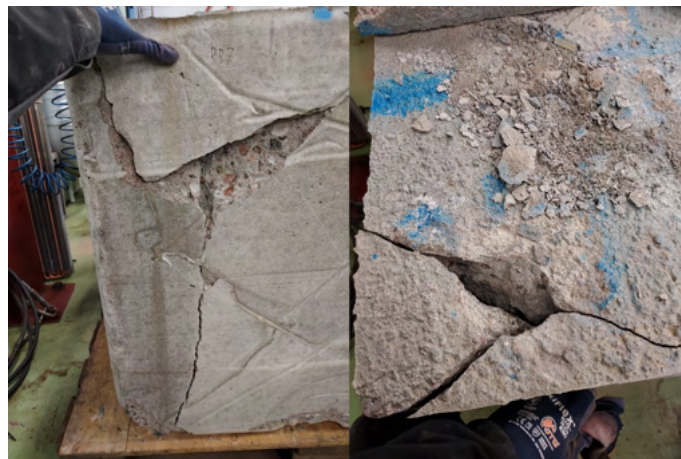
Sample Results: Figure 155 shows the resulting sample after it had broken.

Figure 155: The area around the impact zone.

- There was significant fragmentation and cracking around the impact zone, and the main crack went deep from the tool to the free surface at the bottom of the block. A second, smaller piece also broke off.
- The block took around 50 seconds to break when hitting near the edge.

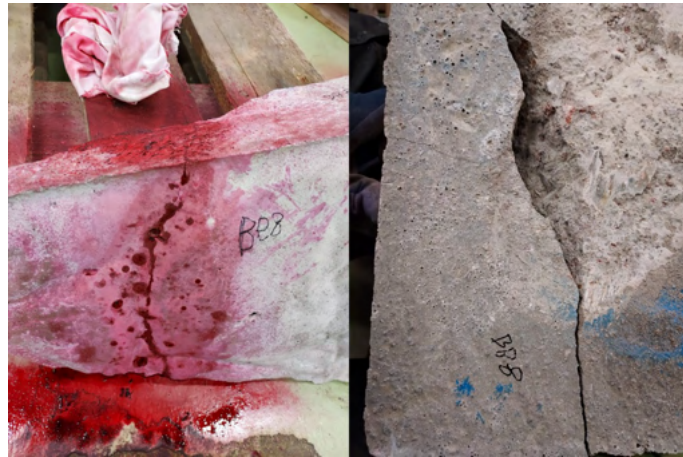
Figure 160: The area around the impact zone.

Sample Results: Figure 160 shows the resulting sample after it had broken.

- There was again some significant fragmentation and cracking around the impact zone of the tool but the main piece broke off cleanly apart from this, with a small crack forming to the free surface perpendicular to the main crack.
- The block took around 97 seconds to break when hitting near the edge.

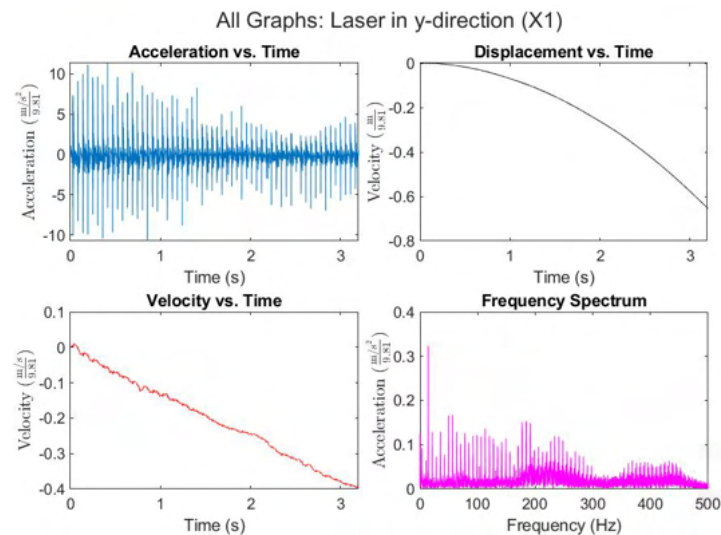
Figure 161: Results from the Laser Measurements on the Tool.

Laser in y-direction: Figure 161 below shows tool vibrations in the y-direction.

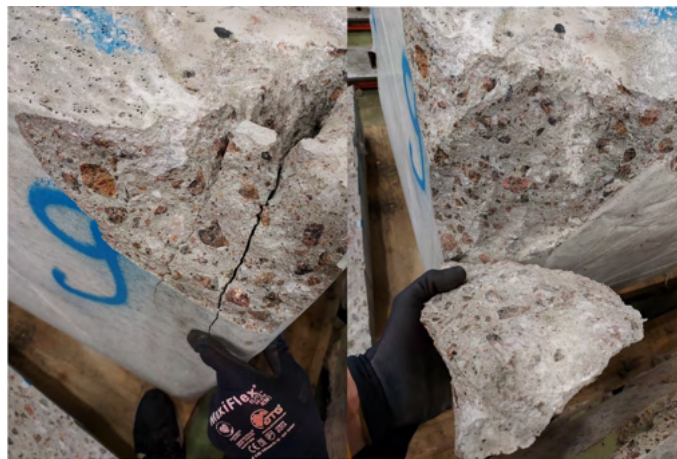
Figure 165: The area around the impact zone.

Sample Results: Figure 165 shows the resulting sample after it had broken.

- There was significant fragmentation and cracking around the impact zone of the tool and a couple of main pieces broke off the main block, but their cracks were parallel to each other.
- The block took around 99 seconds to break when hitting near the edge.

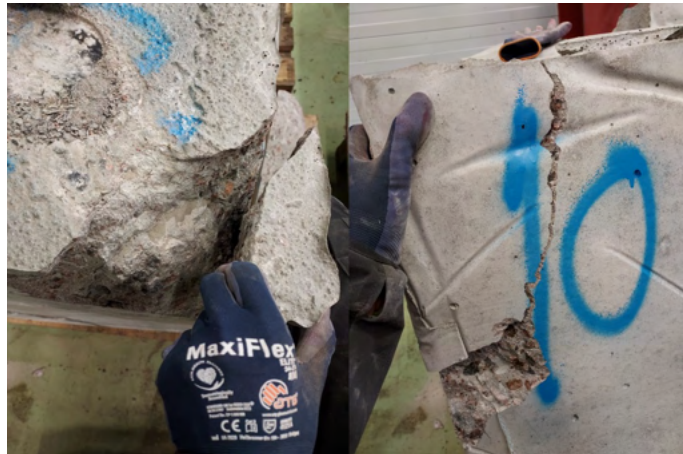
Figure 170: The area around the impact zone.

Sample Results: Figure 170 shows the resulting sample after it had broken.

- A relatively small piece broke off from the edge. It did not fragment into multiple larger pieces, but there was fragmentation around the impact zone and around the main crack near the free surface.
- The block took around 61 seconds to break when hitting near the edge.

Therefore, the blunt tool clearly causes more fragmentation than the wedge tool on the high strength concrete, but the high strength concrete also breaks off much more cleanly than the normal concrete. Fragmentation usually occurred around the impact zone. If another large crack developed from the main crack, it was not necessarily perpendicular to the main crack.

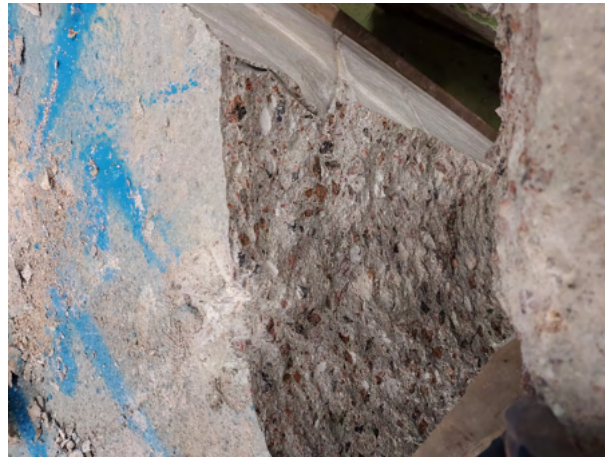
Figure 175: The area around the impact zone.

Sample Results: Figure 175 shows the resulting sample after it had broken.

For CH0.9, the following things are noticeable about the sample:

- There was no fragmentation or cracking around the impact zone. The piece broke off cleanly in one piece.
- The block took about 30 seconds to break when it was hit near the edge.

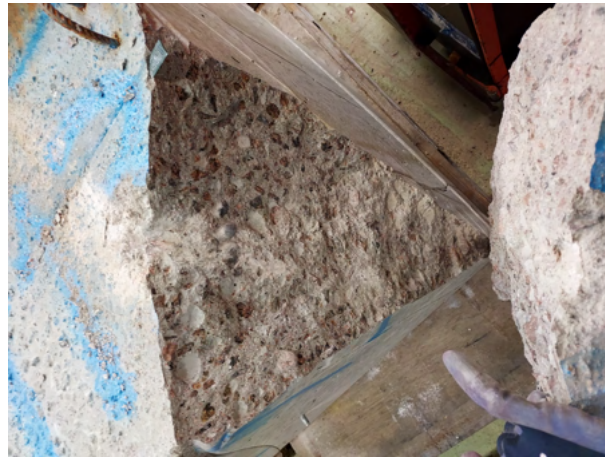
Figure 185: The area around the impact zone.

Sample Results: Figure 185 shows the resulting sample after it had broken.

For CH8, the following things are noticeable about the sample:

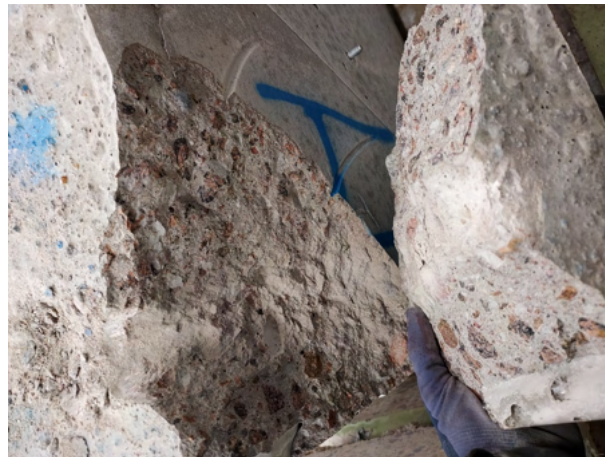
Figure 190: The area around the impact zone.

Sample Results: Figure 190 shows the resulting sample after it had broken.

For CH14, the following things are noticeable about the sample:
